## Is your Arc Flash Risk Analysis adding to confusion or improving employee safety?

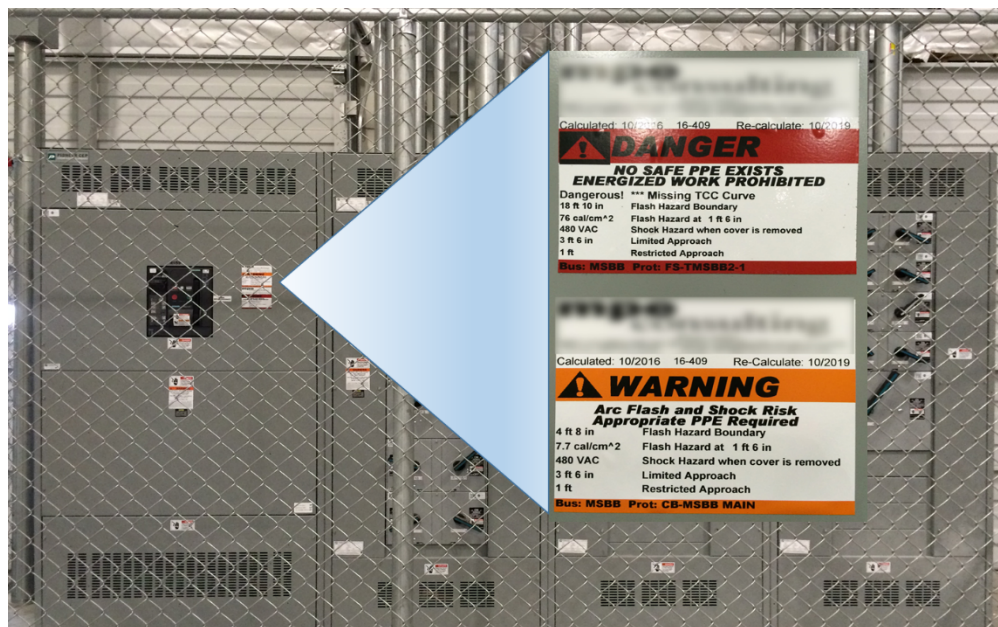
- Undefined boundaries
- Undefined PPE classifications
- Multiple labels on a single asset (example above)
- Non-compliant, missing or damaged labels (non-compliant example below)
